In-depth study of accidents involving light goods vehicles

T Serre*, C Perrin*, M Dubois-Lounis*, C Naude*

*IFSTTAR, Department for Transport Health and Safety, Laboratory of accident mechanism analysis, 304 chemin de la Croix Blanche, 13300 Salon de Provence, France

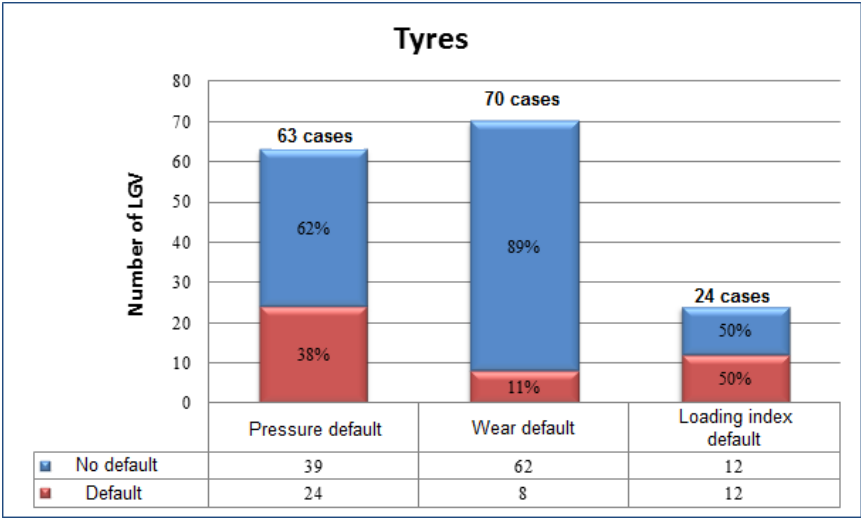
Figure 6. Repartition of tyres defaults

Figure 6 presents the frequency of appearance of these defaults.

These results lead to the fact that the maintenance of LGV is insufficient concerning tyres. Indeed more than one third of LGV presents an under-inflation problem. Nevertheless few wear defaults are recorded. It could indicate that the regulatory maintenance is well done, but much less the basic maintenance such as the check of tyres pressure. Actually these vehicles are often used by several drivers which can result in negligence in usual maintenance. Moreover, even if the sample is small with 24 cases, 50% of LGV have a loading index lower than the manufacturer recommendation.

Among the 90 LGV listed, 7 have a tyre technical default which played a role in the proceedings of the accident, one was a blow-out, 4 were pressure defaults, one a wear default, and one a combination of pressure and wear default. It could be useful to encourage manufacturers to equip LGV with tyre pressure sensors as it exists for some passenger cars) in order to prevent this technical problem.
