# Heavy Truck Crash Investigation and Data Collection Methodology on Indian National Highways

Jeya Padmanaban\*,  
Ravishankar Rajaraman\*\*, Swastik Narayan\*\*, Greg Stadter\*, Bharat Ramesh\*\*

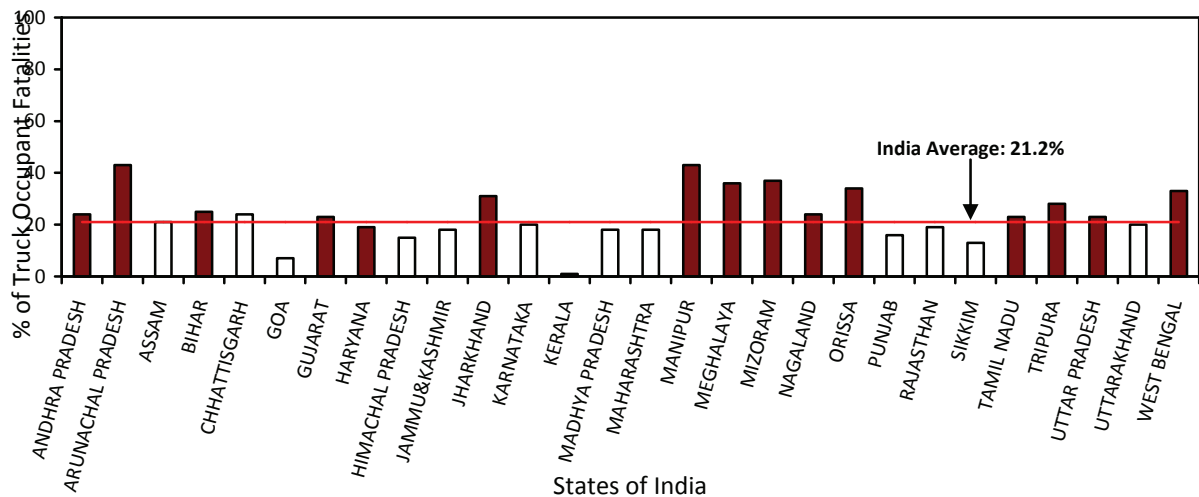
Figure 1. Percentage of Traffic Fatalities to Truck Occupant by State in 2008

As per the National Crime Records Bureau, truck occupants have constituted the highest number of fatalities among all road users. Road fatalities data from 2005 to 2008 show that truck occupants accounted for an average of 21% of all road traffic fatalities [1]. In 2008, 25,135 truck occupants died in road traffic accidents in India [1]. Figure 1 shows the percentage of truck fatalities in each state in the year 2008, with the horizontal line showing the percentage of all India truck fatalities. Out of the 28 states, 15 states have truck fatalities as the highest among all other road user fatalities (Shaded bars).

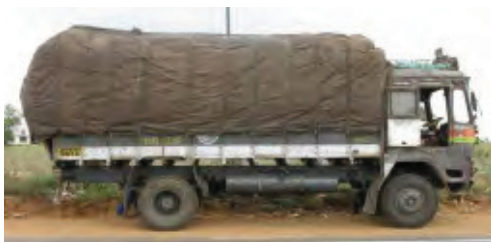
*a. Straight Unit Truck*

There were mainly four types of heavy trucks commonly seen plying on the Indian roads; straight unit truck, tanker, tractor (with/without a trailer), and tipper. Examples are shown in Figure 3. During vehicle examination, the type of truck, including the cargo being carried, was noted.

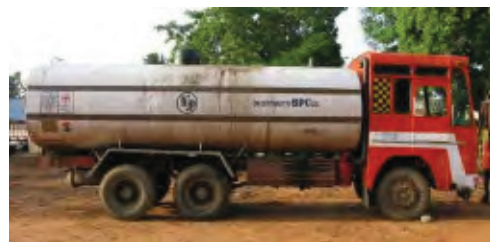
*b. Tanker*

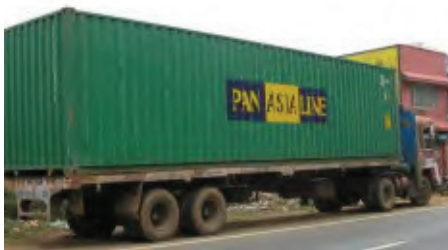
*c. Tractor with trailer*

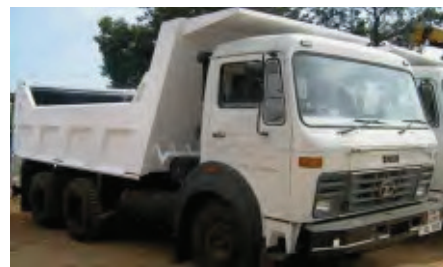
*d. Tipper*

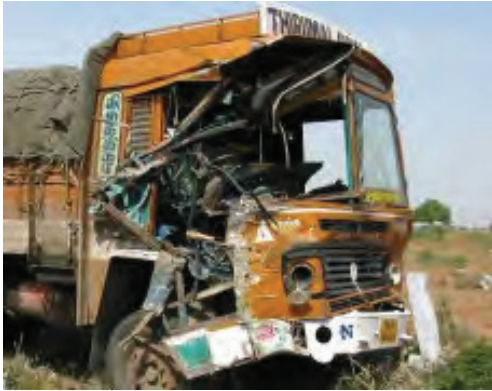
Truck type: Straight unit (2 axle)

Crash type: Head-on collision

Direct damage width: 27 cm from right bumper corner

Maximum crush: 126 cm

TDC: 12FRAN7

Figure 4. Truck Damaged in a Crash with Crash Severity Details

Crash damage and severity involves recording damage information such as impact type, location of direct and indirect damage, damage measurements (such as height and width), crush profile, and maximum crush. This information was later applied in coding the Truck Deformation Classification or TDC [5], as shown in Figure 4.

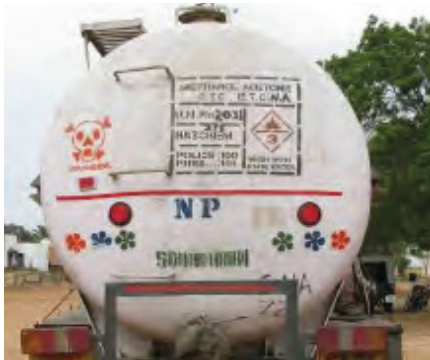
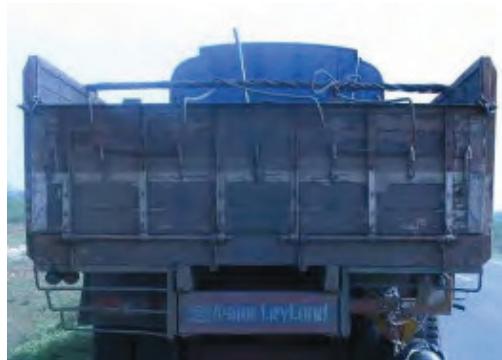
Figure 5. Truck with Good Conspicuity Features (left), Truck with Poor Conspicuity Features (right)

Researchers examined every crashed truck for the availability of reflectors on the front and rear of the vehicle, in adherence to the Rule 104 of the Central Motor Vehicle Rules (CMVR), India [6]. This rule states that every goods transport vehicle should have two white reflectors in the front and two red reflectors in the rear (on both sides), with the minimum reflecting area of each reflector being 28.5 square centimeters. The reflectors also need to be clean, free from any dirt on the surface or peeling for better conspicuity. Figure 5 shows examples of trucks with good and poor conspicuity features.

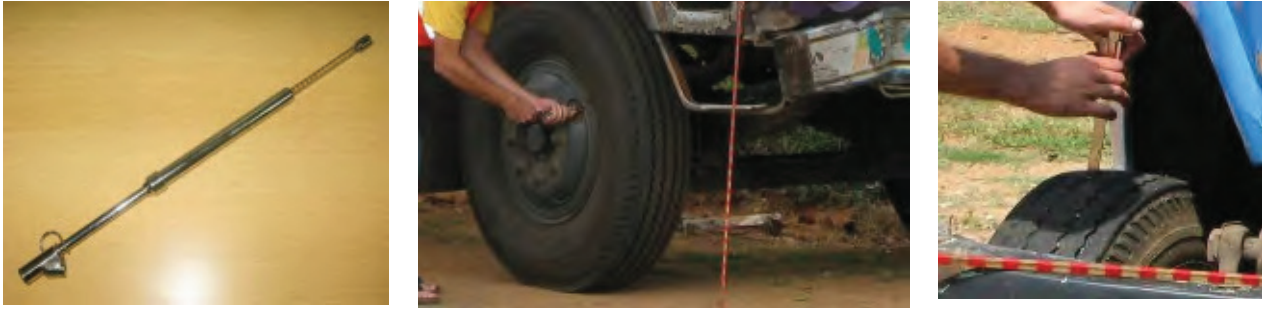
Figure 6. Truck Tire Pressure Gauge (left), Researcher Checking Tire Pressure (center), Tread Depth of Crash Involved Truck (right)

Adequate tire pressure and tire tread depth is necessary for better control of a vehicle on road. By checking the tire pressure of a crash vehicle it can be determined, if the crash occurred due to a tire burst before lose of control. The gauge used for checking the tire pressure in trucks is shown in Figure 6. Also the tread depth of each tire of the truck was measured using the depth probe of a vernier caliper, and the tires were rated as good/fair/poor based on the tread depths measured.

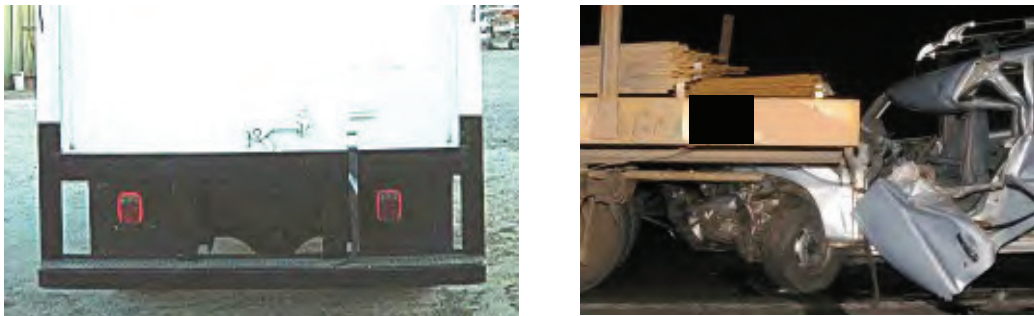
Figure 7. UPD in a Truck (left) and an Under-Ride Crash (right)

**Under-Run Protection Devices (UPD)** are safety equipment fitted on trucks (as shown in Figure 7) to prevent under-rides and used to decrease the crash severity and injury severity when smaller vehicles are involved. The presence of these devices on the front, rear and sides of a truck was noted. The ground clearances of the truck on all sides were also recorded.

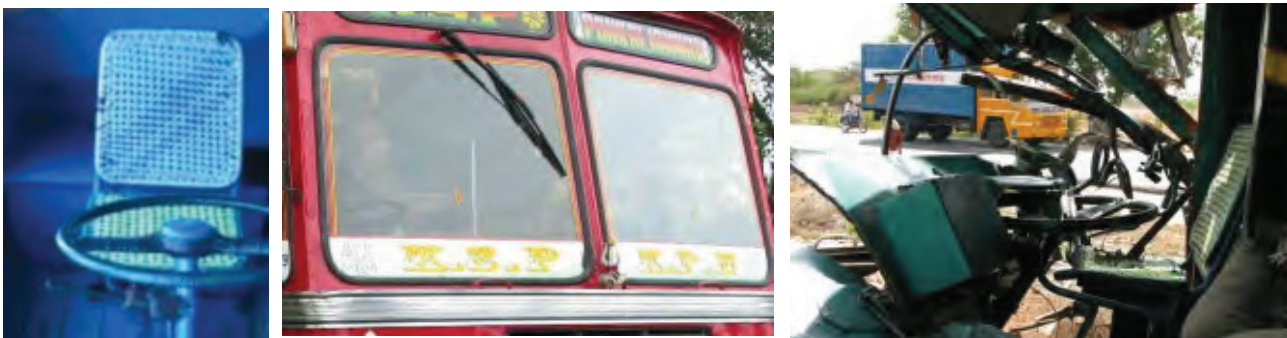
Figure 9. Poor Seating for Truck Drivers and Absence of Seat Belts (left); Wiper Availability only on Driver Side (center); Weak Cab Strength (right)

The type of driver seats present in the truck was recorded. Any seat not of the OEM quality (an example shown in Figure 9) was rated as poor. Any driver visibility issues such as like poor/cracked glazing, availability of wiper only on the driver side, and tiny rear view mirrors was checked. The truck was also checked for the availability of power steering.

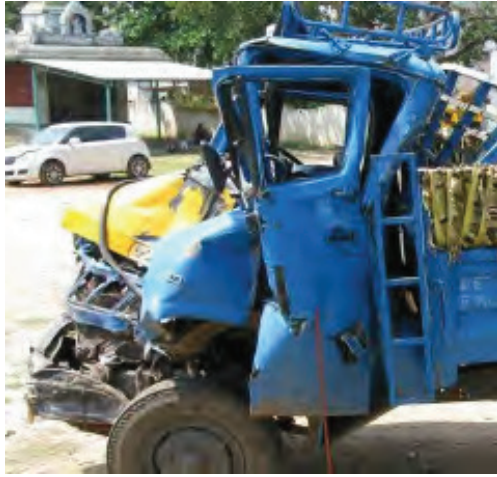
Intruding Component	Intrusion Magnitude (in cm)
A-pillar	44
Instrument panel	54
Cab rear deformed due to cargo	20

Figure 10. Intrusion Measurements of a Truck Colliding with Roadside Tree

The truck involved in the crash was inspected internally to locate intrusions into the cab. The intrusion measurements were taken in the crashed vehicle and then compared with those of an exemplar vehicle to obtain the amount of intrusion into the cab. An example of the intrusion measurements of a crash truck are shown in Figure 10.

Occupant contact evidences such as hair samples, blood smears, windshield cracks, teeth marks, stress marks on dashboard, bent steering wheel, etc. were recorded. Photographs of all contacts were also taken for future reference and analysis. The cab strength, in many cases, was very weak as shown in Figures 10, and the interiors were distorted making it difficult to find occupant contact evidences.

With the cooperation of the police and health department, researchers were able to obtain injury reports on crash victims from the admitting hospitals. After receiving the injury reports, the sustained injuries were coded using the Abbreviated Injury Scale (AIS) [7], and International Statistical Classification of Diseases, 10<sup>th</sup> Revision (ICD-10) [8]. The injuries coded were then correlated to their respective injury sources (intrusions, occupant contacts), which gave a clear idea of the occupant kinematics during the crash and the causes of injuries. This helped to determine ways to mitigate the severity of such injuries. The injuries also gave an indication on the use of safety systems by the occupants. Table 2 shows an example of injury correlation of a truck occupant, seated in the passenger seat of the truck shown in Figure 10.
