# Heavy Truck Rollover Crashworthiness Utilizing Sled Impact Testing

B Herbst\*, J Bish\*, S E Meyer\*\*, A O Nelson\*\*, S Forrest\*\*, L Bell\*\*, C Clarke\*\*

**Abstract** - Rollovers continue to be a major source of heavy truck fatalities when compared to other accident modes. Real world rollover accidents are analyzed and two distinct damage patterns are identified. Damage to heavy truck roofs can occur from lateral loading that transitions to vertical roof loading as the vehicle rolls onto its side and then over onto its roof. A second load path can occur when the vehicle has rolled onto its side and furrows into the ground generating large longitudinal friction forces between the roof and ground. A review of the previous literature and various test methodologies are presented. A sled impact test methodology is presented which allows for structural assessment of a heavy truck cab's crashworthiness in both of these loading environments. Two test series are presented using the sled impact test methodology in order to analyze real world truck rollovers using varying impact platen and contact angles. The structural deformation and failure patterns were found to be consistent wi

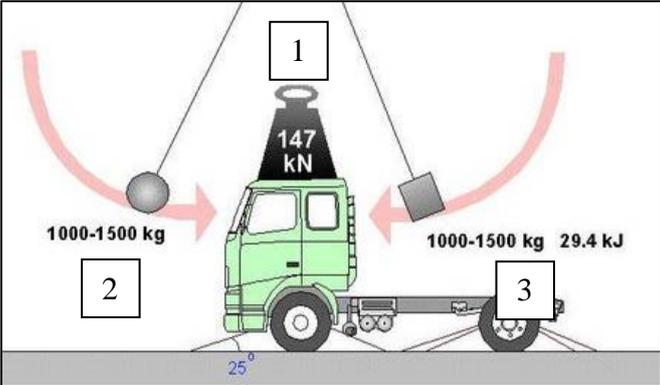
Figure 1: Swedish Impact Test Configuration

The Swedish Impact Test is a heavy truck test method that has been used by Volvo since 1959 to test their heavy truck cabs ability to withstand rollovers [7]. This methodology is comprised of three tests. The first test subjects the truck cab roof to a distributed, static vertical load of up to 33,075 lb (15,000 kg). After this, a cylindrical pendulum weighing more than one ton is swung into one of the cab’s front A-pillars from a height of up to 10 feet (3.0 m). Finally, in the third test, another square pendulum weighing approximately a ton strikes the rear wall of the cab with the same amount of energy. In order to pass the Swedish impact tests, the same truck cab, having been subjected to all three tests, must maintain the occupant survival space, see Figure 1.

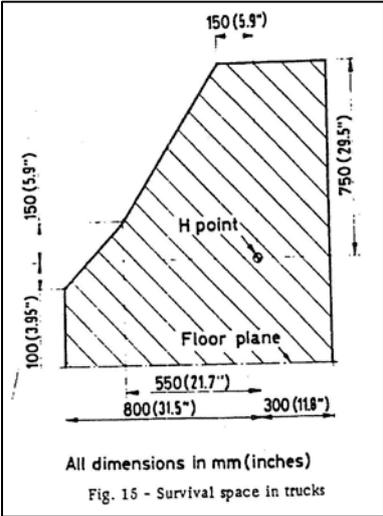
Figure 2: Figure 15 from Reference [9] on Survival Space in 1969

The survival space concept has been well understood since the 1950s, when DeHaven presented packaging engineering principles for the increased protection and safety of valuable goods in transit [8]. Beginning in the late 1960s most auto manufacturers incorporated the concept of “survival space” or “non-encroachment zone” within the occupant compartment, which is not to be intruded upon in a rollover. In 1969, Franchini published “The Crash Survival Space”, in which he discussed the importance of maintaining a post-crash survival space of 29.5 inches (74.9 cm) above the occupant’s H-point in all crash modes, including rollovers of cars and trucks [9], see Figure 2.

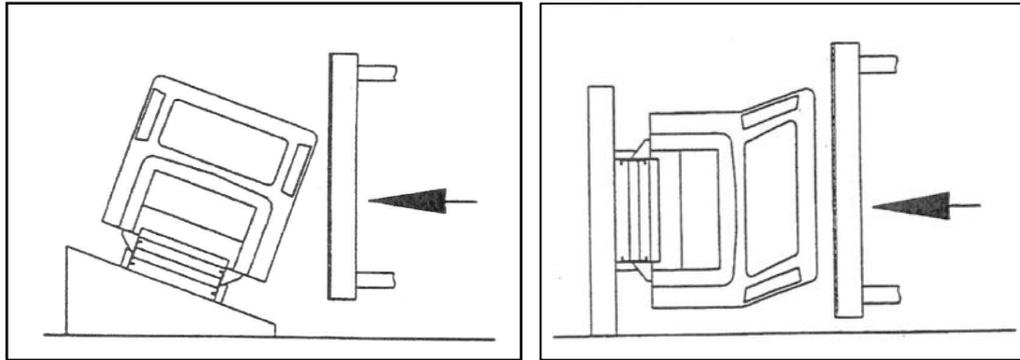
Figure 3: SAE J2422 Dynamic Pre-Load and Quasi-Static Roof Load Configurations

In 1998, SAE developed a recommended practice, SAE J2422, to evaluate heavy truck cab roof strength resistance in a 180-degree rollover [20]. This procedure, revised in 2003, has two phases for loading the roof, “a dynamic pre-load that simulates the side loading of the upper cab as the vehicle rolls past 90 degrees and a quasi-static roof loading that simulates the loading of the cab when the vehicle is inverted.” For the first phase, the truck cab is affixed to the ground at a roll angle of 20 degrees and the pre-load is applied by the vertical-faced of an impact sled to the truck cab’s roof, see Figure 3. The sled should weigh 5,000 to 15,000 lb (2,268 – 6,804 kg) and should impact the cab with a kinetic energy of up to 13,000 ft-lb (17,626 J). The second phase involves static loading the roof through its vertical axis until it reaches a load equal to the maximum capacity of the front axle up to 22,046 lb (10,000 kg) with no energy requirement. After both tests, the vehicle must exhibit survival space allowing for accommodation of the ECE Regulation 29 seated manikin.

The SAE applied a similar testing approach in the development of the J2422 and J2423 recommended practices. SAE J2422, “Cab Roof Strength Evaluation – Quasi-Static Loading Heavy Trucks”, incorporates two tests to a cab structure. The first, pre-load, impact is with the cab set at 20° of roll and has an energy requirement based on the energy to tip the cab from its static stability position to a rest position on its side and is capped at a maximum of 13,000 ft-lb (17,626 J). The second impact is a vertical impact to the entire top of the cab structure with a load requirement based on the maximum rated capacity of the front axle subject to a maximum of 22,046 lb (98,061 N). After the dynamic pre-loading impact and the quasi-static roof loading, the cab must retain a survival space allowing accommodation of the manikin defined in ECE Regulation 29. At the time SAE J2422 was issued, 01/1998, SAE also issued standard J2423, “Cab Roof Strength Evaluation – Dynamic Loading Heavy Trucks”. The only difference between the two standards was the change from quasi-static to dynamic loading for the second, vertical loading test. However, SAE J2423 does not have a recommendation or guidance for the energy of the dynamic test. SAE J2423 was cancelled in January 2004.

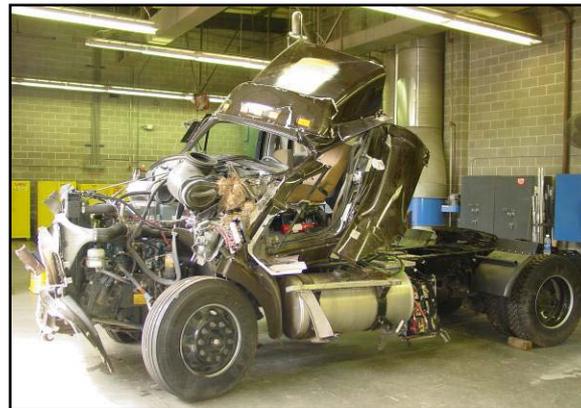
Figure 4: Series 1 Accident Vehicle

A real world accident involving a Sterling A9500 series heavy truck was analyzed. In this accident, the heavy truck was involved in an on-road impact with a passenger car and subsequently exited the roadway before overturning onto its driver's side. The vehicle continued to slide on its driver's side, generating large frictional loads, before interacting with the sloped shoulder embankment adjacent to the roadway. The accident vehicle is shown in Figure 4.

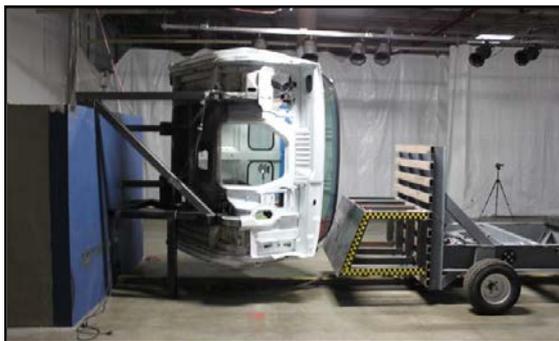
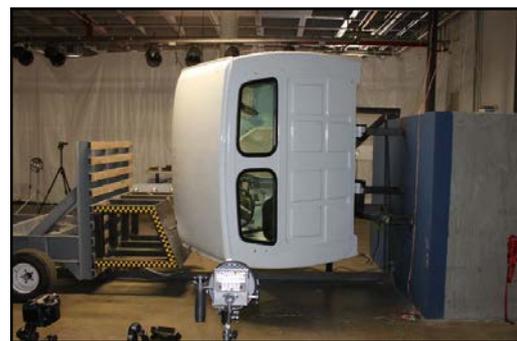
Figure 5: Series 1 Test Set-Up

In order to evaluate the roof loading and occupant compartment roof deformation from this accident, with a large frictional component, the following sled test set-up was utilized. Using the OEM cab frame mounts, the occupant compartment was rigidly mounted at a 90 degree driver's side leading roll angle with 35 degrees of pitch such that the sled striking platen would make initial contact with the driver's side A-pillar-header junction. The platen attached to the front of the sled was oriented at 20 degrees from vertical, see Figure 5.

Front View of Cab

Rear View of Cab

As there was no publicly available roof strength data for this cab structure with the amount of crush resulting from this accident, a roof strength approximation was made and the test conditions were selected in order to achieve, or overshoot, the deformation level observed in the subject accident truck cab. The initial impact speed was targeted at 19 mph (30.6 kph) for an approximate energy of 60,000 ft-lb (81,349 J).

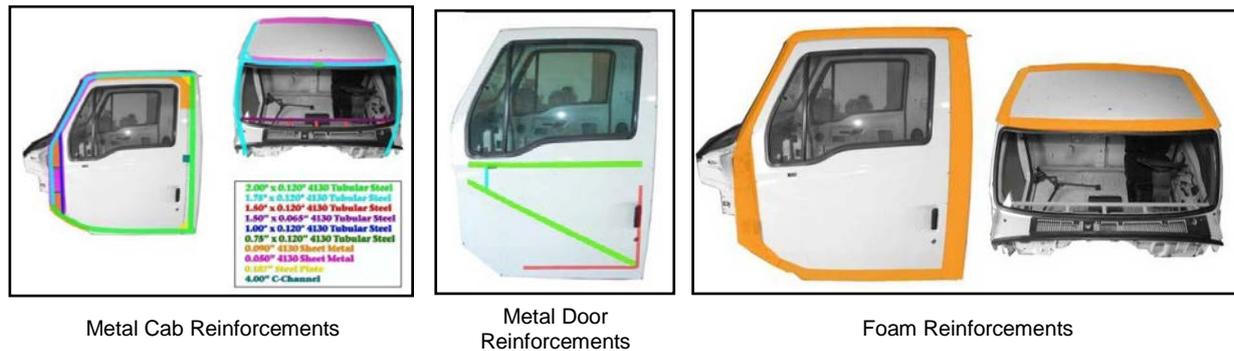
Figure 6: Cab Reinforcement Schematics

The deformation patterns from Test A and the accident vehicle were utilized to determine the location and the extent of reinforcement necessary to protect an occupant in this or other rollover impacts. A

second Sterling A9500 series heavy truck occupant compartment and driver's door were structurally reinforced based on this structural assessment. Due to the large door opening, it was determined that the door need to be reinforced to act both as a load path and to insure the door would remain closed and intact in the collision. The structural reinforcements included the addition of integral 4130 steel tubing and rigid polyurethane foam to the cab's structure. The total weight of the reinforcements was 220.3 lb (99.9 kg). These in-house retrofit reinforcements would weigh significantly less if implement in the production design process. With the implemented steel reinforcements welded in place, rigid polyurethane foam was then added to fill voids in the structure, such as the front header, side headers, rear header, A-pillars, B-pillars, and rocker rails, see Figure 6. The impact configuration for Test B was to be determined from the results of Test A compared to the accident vehicle.

The first type of reinforcement utilized in Test Series 1 is an example of an integral reinforcement. Typically, this type of reinforcement involves adding material to the inside of or adjacent to an existing structure without changing the exterior profile of the vehicle or cab. Integral reinforcements are analogous to a stronger production cab which can be manufactured by the various OEMs. In Test Series 1, the strength and rigidity of the structure was increased by inserting tubular and sheet metal steel reinforcements with foam filling inside the existing cab structure and compartment trim.

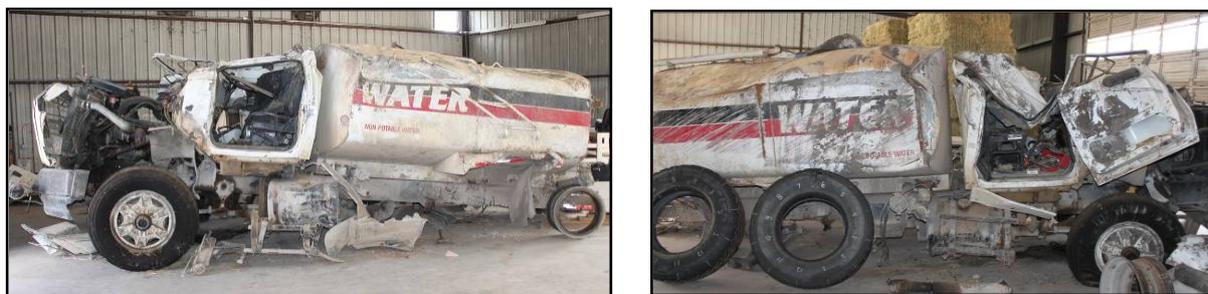
Figure 7: Series 2 Accident Vehicle

A real world accident involving a 1991 Ford L series heavy truck was analyzed. In this accident, the heavy truck equipped with a water tank was traveling at highway speeds when a tire failed causing the vehicle to leave the roadway before rolling passenger side leading and coming to rest on its roof. The accident vehicle is shown in Figure 7.

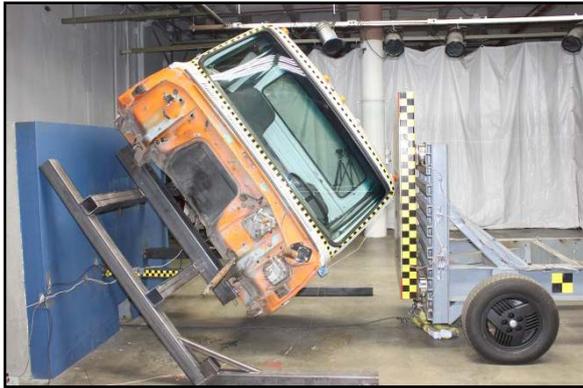
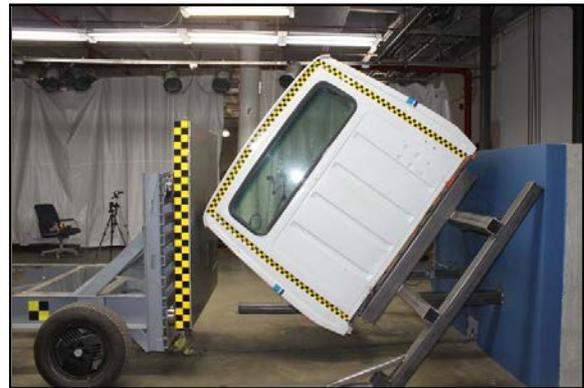
Figure 8: Series 2 Test I Setup

The cab was mounted to a rigid barrier face at the angles specified below for each test, see Table 2. The impact sled, weighing 7,275 lb (3,300 kg) was accelerated to the target speed for each test and impacted the cab. The sled impact face was approximately a 5 foot (1.52 m) square flat surface and instrumented with 4 load cells, see Figure 8.

Front View of Cab

Rear View of Cab

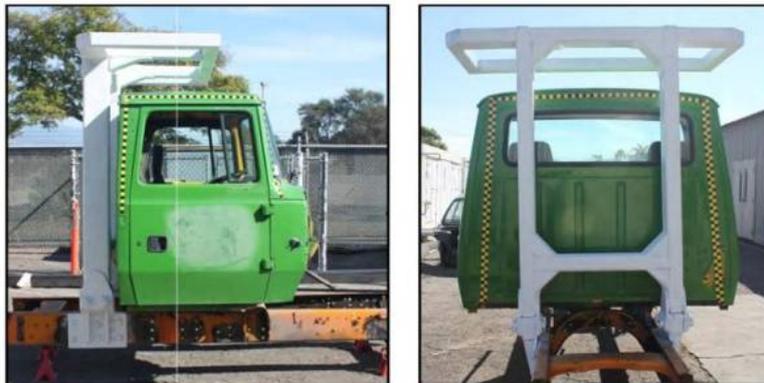
Figure 9: ROPS Installation

A second set of tests were conducted using an equivalent L-series truck cab fitted with external ROPS system and subjected to the same test conditions as the production cab. The ROPS system was fabricated primarily out of 4 x 4 inch (10.2 x 10.2 cm) and 4 x 8 inch (10.2 x 20.4 cm) square tubing with a 0.375 inch (0.95 cm) wall thickness and was based on a design purchased from ROPS PTY [22] which is a commercially available design from Australia. The ROPS framework attaches behind the cab to the truck's chassis frame and extends above the cab roof and forward over the occupant space, see Figure 9.

The second structural reinforcement methodology, presented in Test Series 2 involves a rollover protection system, or ROPS, and is an example of an external reinforcement. ROPS are externally mounted, rigid cage-like structures that are designed to protect the occupant compartment in rollovers by limiting vehicle structure intrusion into the occupant's survival space. These reinforcements can be utilized on existing heavy trucks with weaker roof structures. Many companies in Australia provide ROPS for heavy truck vehicles, such as ROPS Pty. Ltd. [23] and QMW Industries [24] as shown in Figure 16. These designs mount to the truck frame and extend up and over the truck's occupant compartment.

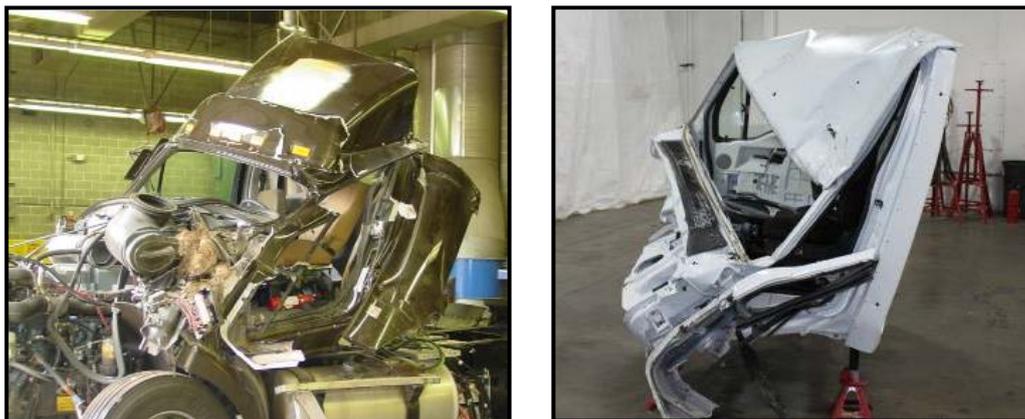
Figure 10: Accident and Test Vehicle Comparison

In Test A, the production truck cab deformed in a manner that allowed the A-pillar/header junction to contact the upper seatback of the driver's side seat and drove the steering wheel column rearward and down onto the seat cushion. During the impact, the fiberglass driver's side door unlatched and fractured, allowing it to separate from the truck cab. The upper portion of the driver's side B-pillar and side header separated at their connecting seam, see Figure 10.

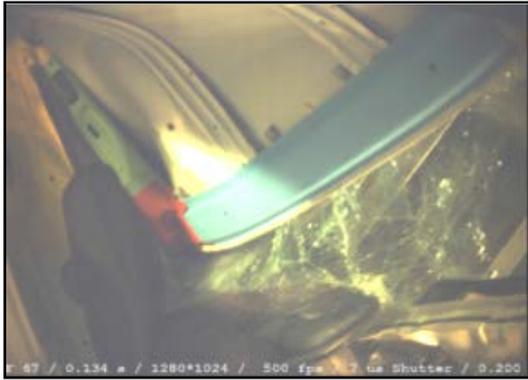
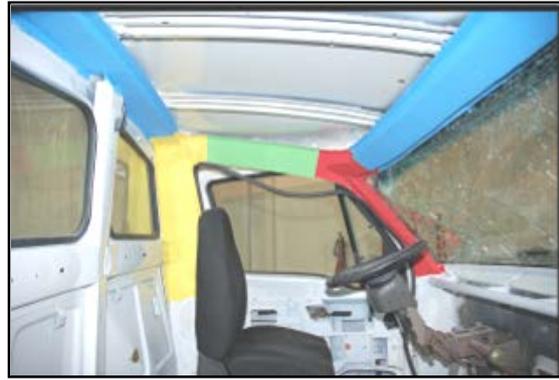
Figure 11: Roof Intrusion Comparison

In order to determine the impact speed and energy for the reinforced test, the amount of energy required to produce the 35.5 inches (90.2 cm) of residual crush, as seen in the accident vehicle, needed to be determined. The production test vehicle crushed 42.8 inches (108.7 cm) statically from an energy input of approximately 58,184 ft-lb (78,887 J) and had a dynamic overshoot of 3.4%. By double integrating the sled accelerometers, the energy and displacement time histories were generated for this test. Using the same dynamic overshoot factor, it was determined that 40,000 ft-lb (54,233 J) of energy would have yielded 35.5 inches (90.2 cm) of static crush. Therefore, the reinforced test, Test B, was run at a sled impact energy of approximately 40,000 ft-lb (54,233 J) in order to compare cab roof deformation between the reinforced test cab and the subject accident cab at the same impact energy level. The reinforced cab experienced a 78% reduction in roof deformation when subjected to the impact energy required to generate the damage measured on the accident vehicle, see Figure 11. Unlike in the case of the real world accident, the reinforced roof test vehicle retained the occupant survival space, see Figure 12.

Video Still of Production Cab Deformation  
(35.5 in (90.2 cm) of A-pillar Displacement)

Reinforced Cab Post Test

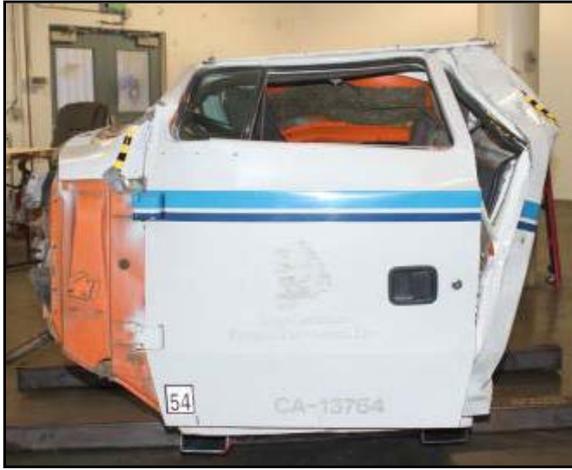
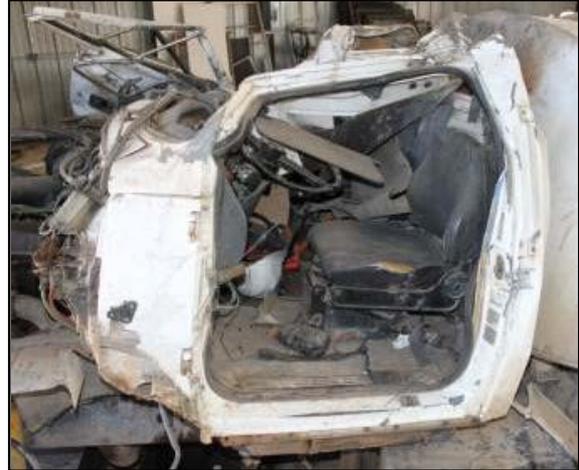
Figure 13: Post Test Series 2 Cab Comparison

In the production test, significant intrusion into the cab occurred during the first test, and the subsequent tests substantially increased the level of intrusion. After being subjected to the series of three sled impacts, the cab sustained numerous structural failures and collapses and severely compromised the occupant survival space. The tested cab had a damage profile consistent with the real world accident vehicle; see Figure 13 and Table 4.

Production Cab

Accident Vehicle Cab

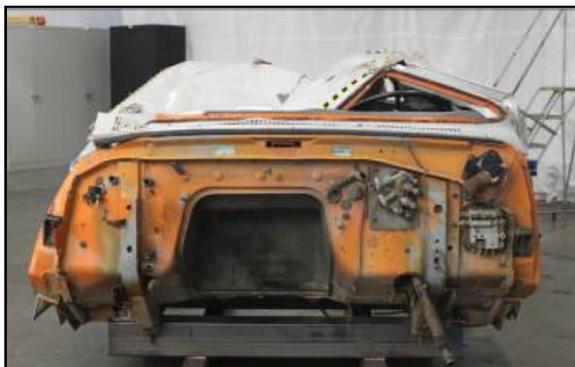
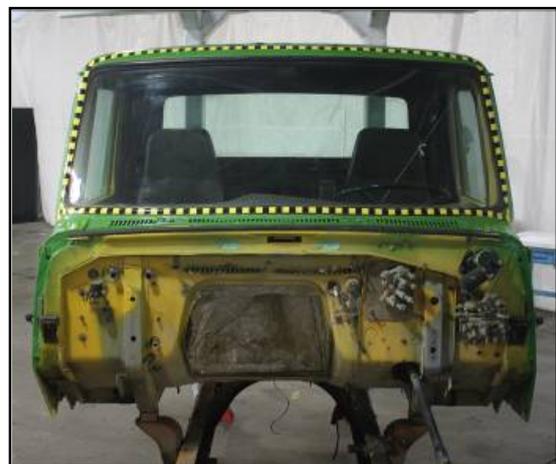
Figure 14: Post Test Series Cab Comparison

In the ROPS equipped cab testing, the ROPS system prevented the impact sled from contacting the cab structure and prevented any intrusion of the cab for all three tests.

Production Cab

Reinforced Cab

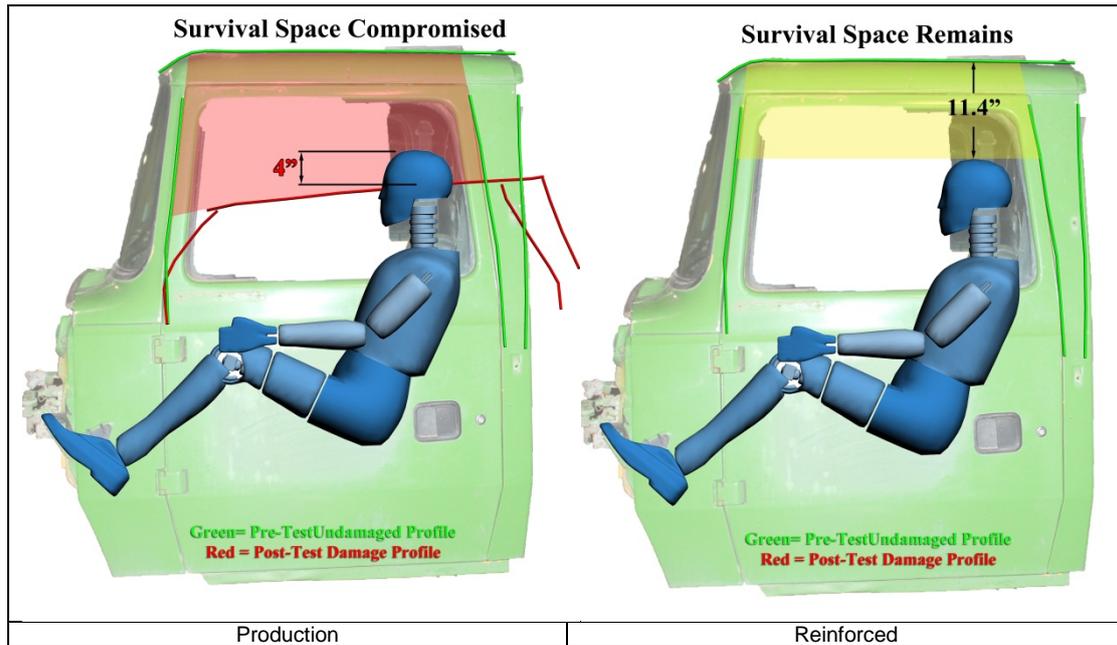
Figure 15: Survival Space Comparison

Each truck cab was surveyed after each test in order to measure any roof deformation. Below is a summary of the cumulative A-pillar and B-pillar deformation of the production truck cab after all three tests. For the ROPS equipped cab, the deformation of the ROPS system itself is provided below since there was no cab deformation and the occupant survival space was completely retained. Figures 14 and 15 depict the deformation to the cab and ROPS after the test series was completed.
