Attenuating Head Impact with Vehicular (Including Heavy Truck) Interiors

S E Meyer*, B Herbst**, A O Nelson*, S Forrest*

*Safety Analysis & Forensic Engineering (S.A.F.E.), 6775 Hollister Ave, Ste 100, Goleta, CA 93117, USA

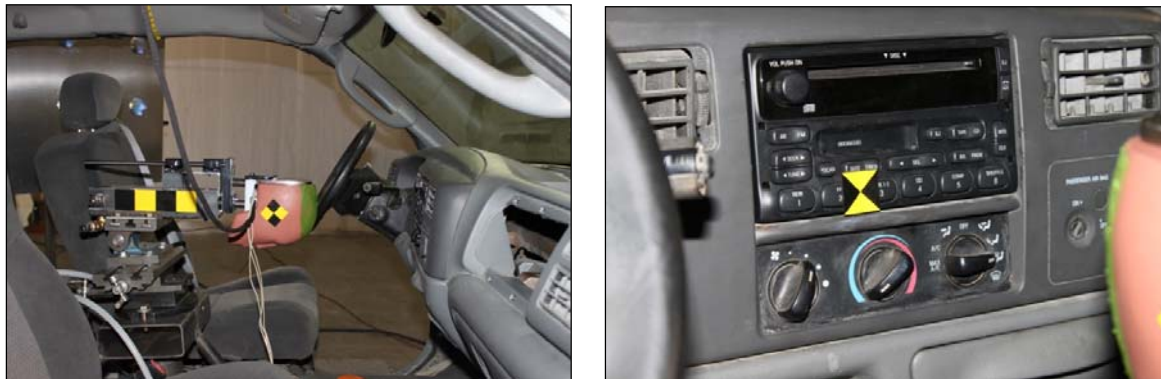
The test setup for the four tests conducted is summarized in Table 6, below. Tests 5a and 5c were conducted with the head form impacting the radio, located in the center of the dash. The radio was replaced between the tests to allow for analysis of the radio post-test deformation. The impact location on the radio was centered between the second and third station preset buttons (Figure 8). For tests 5b and 5d, the head form was launched vertically into the roof panel above the front center

Figure 8. Series 5 Test Setup For Horizontal Impact Into Dash Radio

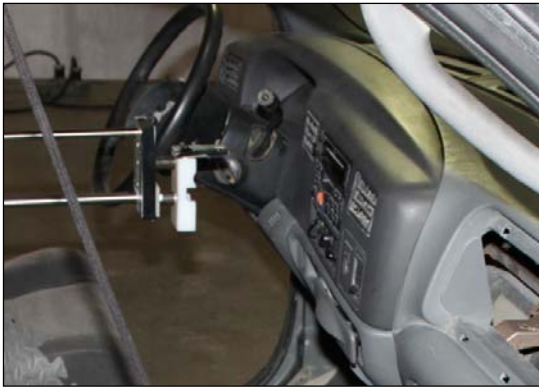
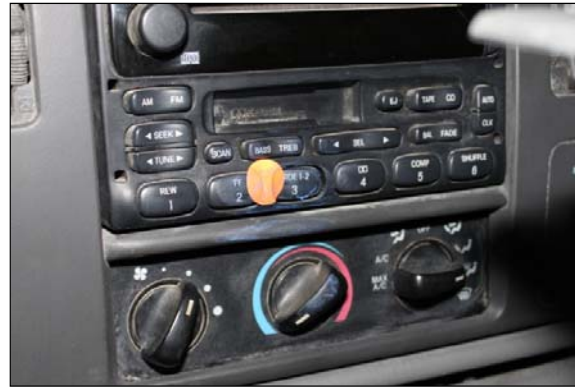
The testing results are reported in Table 7, below. In test 5a, the head form impacted the radio at 10.5 mph (16.9 kph) and indented the second and third radio buttons (Figure 10). Test 5c, which also impacted the dash/radio, at 15.0 mph (24.1 kph), resulted in more deformation to the radio buttons and a larger contact area than that observed in test 5a. Additionally, in test 5c, the impact caused a dislocation of the surrounding dash panel (Figure 11). Test 5b was conducted with the head form striking the roof panel at 10.6 mph (17.1 kph) and resulted in a small but visible outward dent in the roof exterior sheet metal (Figure 12). Test 5d, also into the roof at 15.2 mph (24.5 kph), resulted in a much larger exterior roof panel dent, measuring approximately 3 inches (7.6 cm) in diameter and a maximum depth of approximately one tenth of an inch (2.5 cm) (Figure 13).

Figure 10. Post Test Damage, Test 5a – Dash Impact

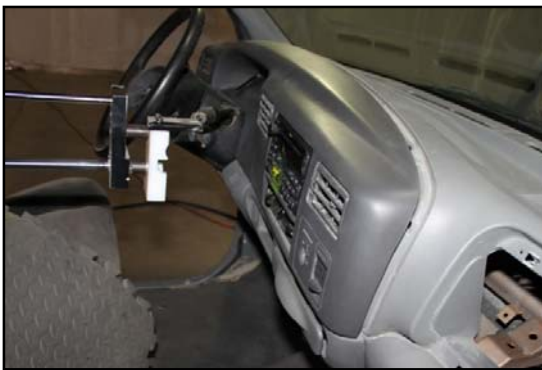
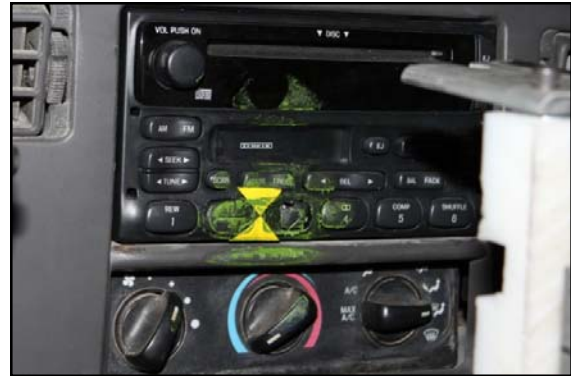
Figure 11. Post Test Damage, Test 5c – Dash Impact

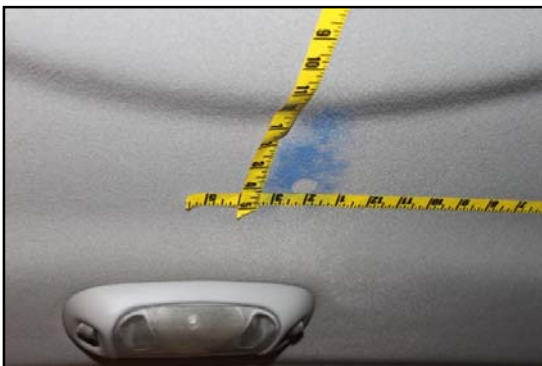
Figure 12. Post Test Damage, Test 5b – Roof Panel Impact

An impact to the roof panel with sufficient force to cause the neck fracture observed in the subject accident would have left observable residual sheet metal deformation that was not seen in the accident vehicle. Considering the results of this testing, compared to the damage documentation on the subject accident vehicle made clear that there was no coordinating deformation on the roof structure of the accident vehicle to indicate the occupant had made such contact with the surface of the roof; however, the radio/dash area was found to exhibit similar deformation to that seen in the presented testing. As such, the FMH launcher testing was able to rule out one proposed impact location (the roof) and confirm the deformation seen to the other (the dash).
