Improving Injury Causation Analysis and Coding in CIREN Using the BioTab Method

Abstract - The NHTSA-sponsored Crash Injury Research and Engineering Network (CIREN) has collected and analyzed crash, vehicle damage, and detailed injury data from over 4000 case occupants who were patients admitted to Level-I trauma centers following involvement in motor vehicle crashes. Since 2005, CIREN has used a methodology known as “BioTab” to analyze and document the causes of injuries resulting from passenger vehicle crashes. BioTab was developed to provide a complete evidenced-based method to describe and document injury causation from in-depth crash investigations with confidence levels assigned to the causes of injury based on the available evidence. This paper describes how the BioTab method is being used in CIREN to leverage the data collected from in-depth crash investigations, and particularly the detailed injury data available in CIREN, to develop evidence-based assessments of injury causation. CIREN case examples are provided to demonstrate the ability of the BioTab method to improve real-world crash/injury data assessment.

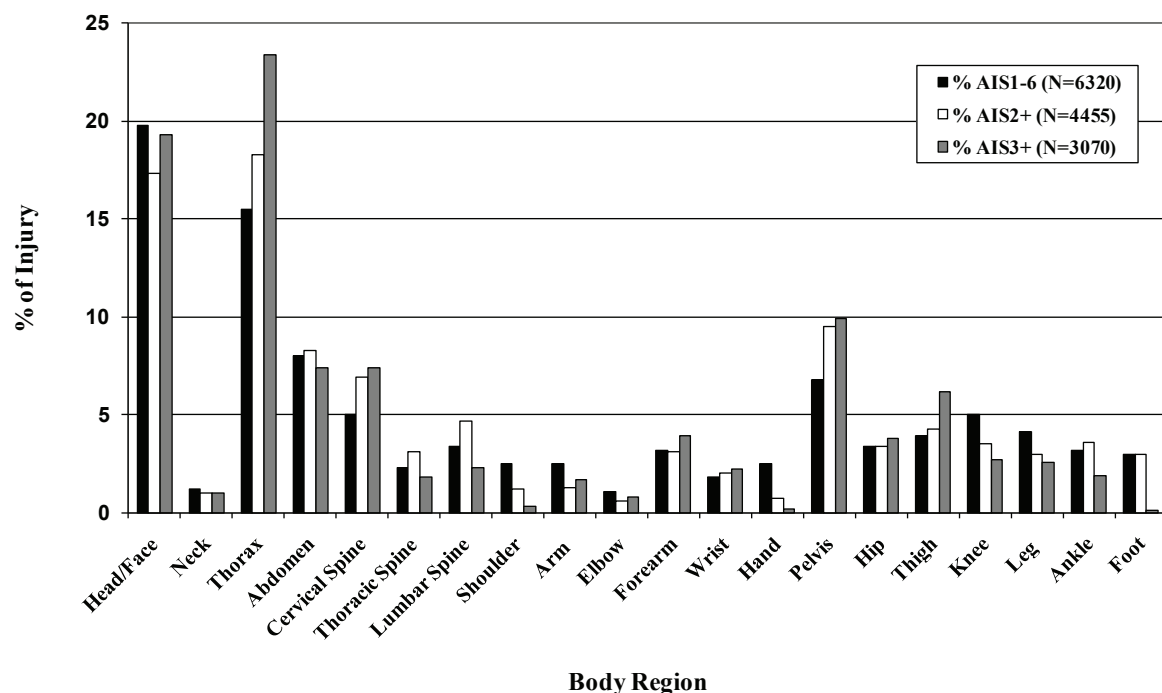
Figure 1 shows the percentages of all injuries for different ranges of injury severity by body region for the 1200 CIREN occupants whose AIS 3+ injuries were coded using BioTab. The largest percentages of injuries occur to the head/face, thorax, and pelvis. With injury causation coding for over 600 serious (AIS 3+) thoracic injuries, the BioTab data in CIREN, combined with NASS-CDS data (Elliott et al. (5)) are a powerful resource to understand how these injuries occur and perhaps how they can be prevented.

Figure 1. Percent of injuries for different ranges of injury severity sustained by CIREN occupants in different body regions

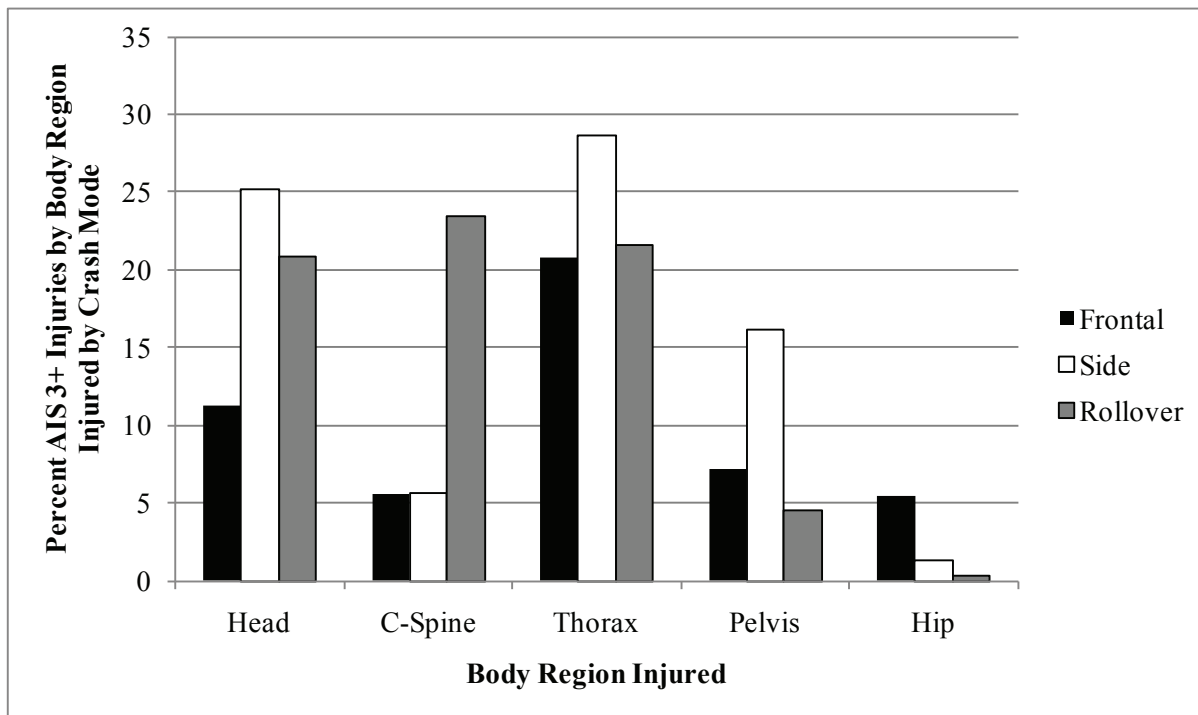
Figure 2 shows the percentages of AIS3+ injuries by injured body region for frontal, side, and rollover crashes in the CIREN BioTab database. For brevity, only percentages of AIS 3+ injuries from the most frequently injured body regions are shown. Note that the thorax injuries are dominant for occupants involved in frontal and side crashes while cervical spine injuries are most common for occupants involved in rollover crashes.

Figure 2. Percentage of AIS 3+ injuries by injured body region for which BioTab analysis was performed on the most frequently injured body regions by crash type

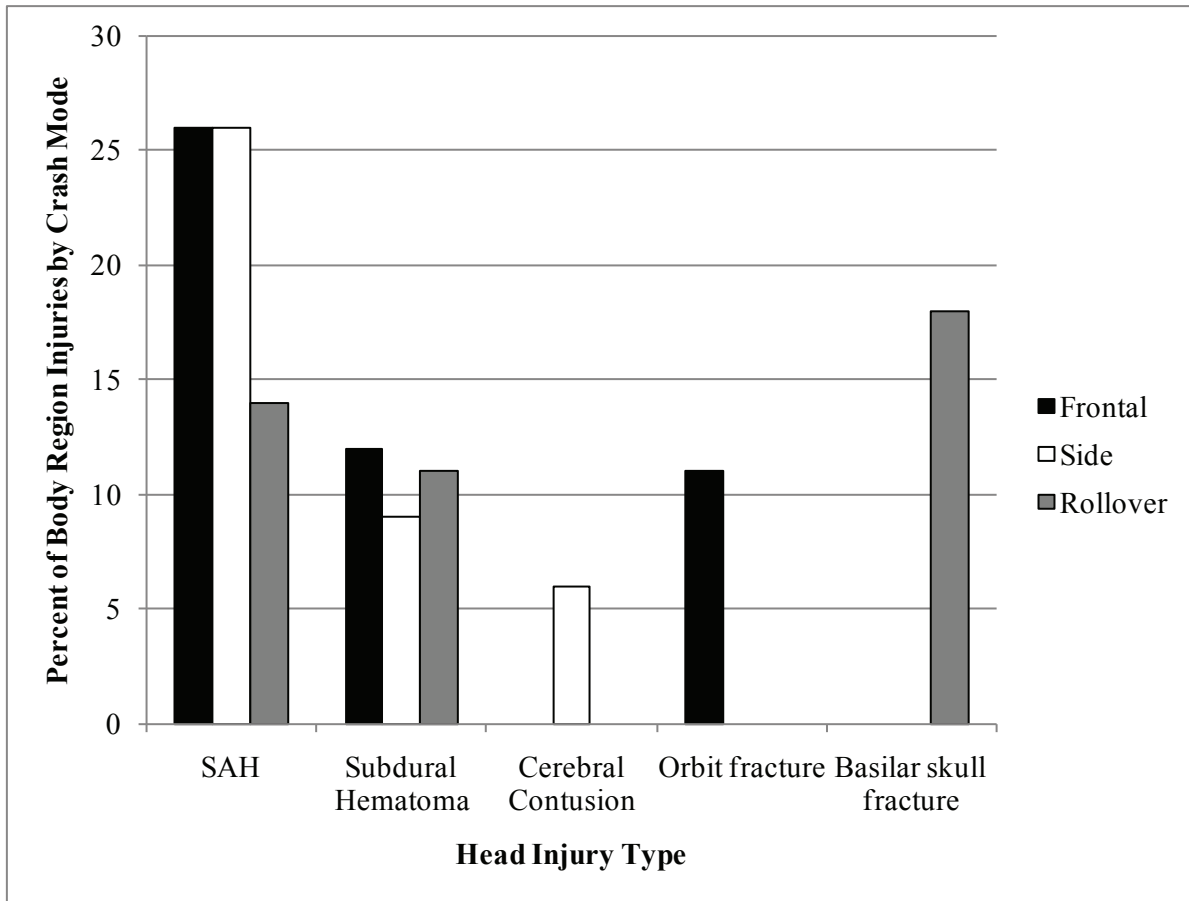
Figures 3, 4, and 5 show the three most common types of head, C-Spine, and thorax injuries as percentages of the total number of injuries to these respective body regions for frontal crashes side impacts, and rollover crashes. Subarachnoid hemorrhage is the most common head injury for frontal and side crashes, while the most common head/brain injury in rollovers is basilar skull fracture. For side impacts, the three most frequent head injuries involve a brain injury or bleed. Figure 4 shows that different crash modes are associated with injury to different structures in the cervical spine and vertebral bodies. Interestingly, the majority of the most common C-spine injuries involve injury to the posterior column of the cervical spine, suggesting a compression-extension mechanism or compression of the c-spine in an extended posture. Figure 5 indicates that, while lung contusions are very frequent thoracic injuries in all crash modes, frontal crashes have higher frequencies of rib fractures, and especially multiple fractures involving hemo- or pneumo-thorax.

Figure 3. Three most common AIS 3+ head/brain injuries as percentages of the total number head/brain injuries by crash mode (SAH = subarachnoid hemorrhage).

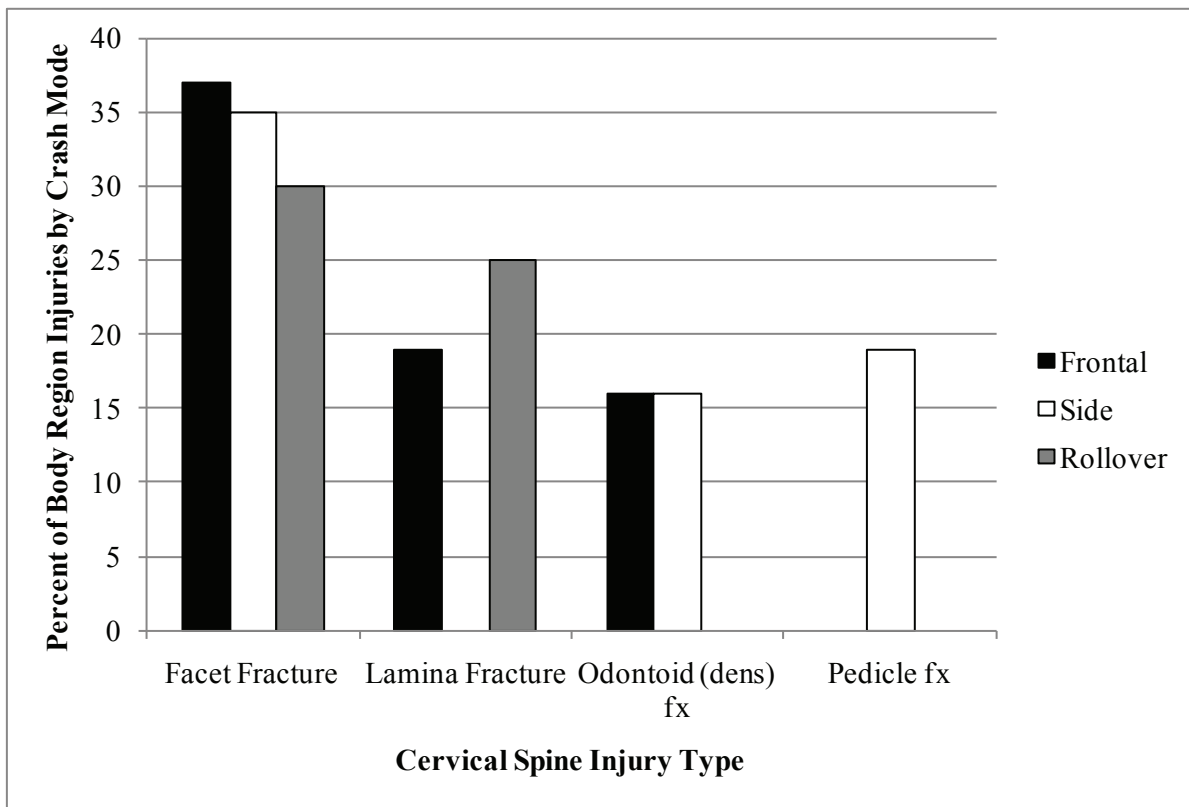
Figure 4. Three most common AIS 3+ C-Spine injuries as percentages of the total number of C-Spine injuries by crash mode.

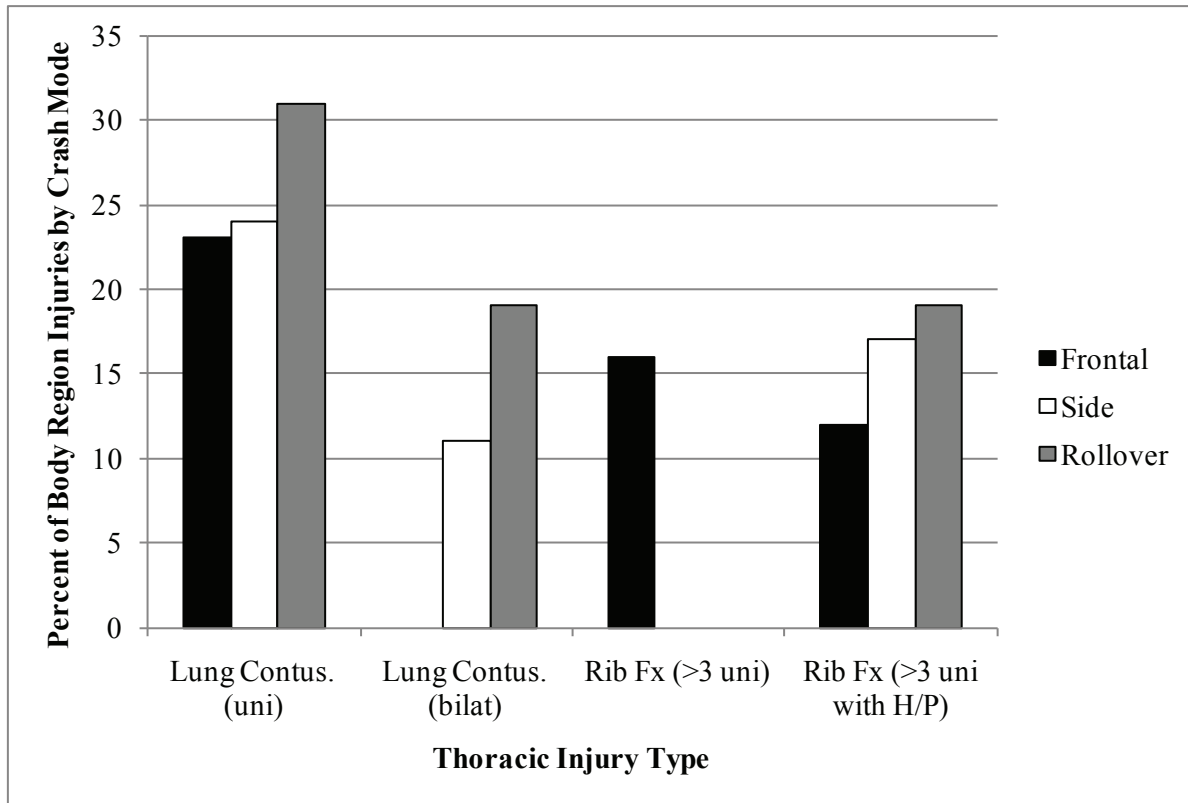
Figure 5. Three most common AIS 3+ thoracic injuries as percentages of the total number thoracic injuries by crash mode. (H/P = hemo- or pneumo-thorax)

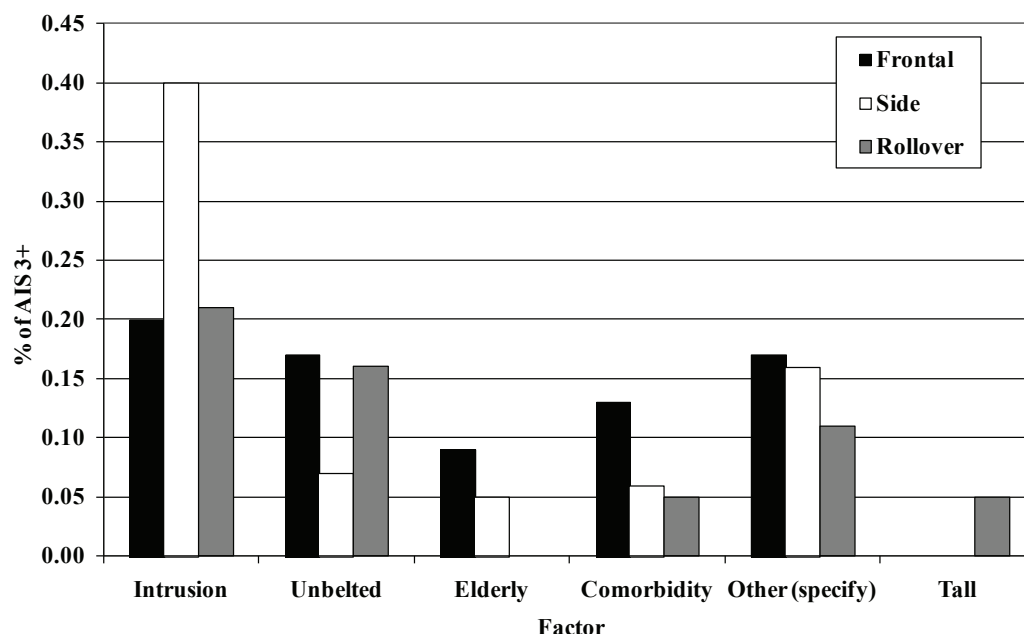
Figure 6 shows the most frequent contributing factors in the BioTab analysis of injury causation. Intrusion, particularly in T-type side impacts, lack of seatbelt usage, and old age are the most frequent contributing factors. Matching these factors to crash modes and injured body regions allows for possible countermeasure development in terms of restraint and/or vehicle structural enhancements.

Figure 6. Top five contributing factors as percentages of all AIS 3+ injury in frontal, side, and rollover crash modes.

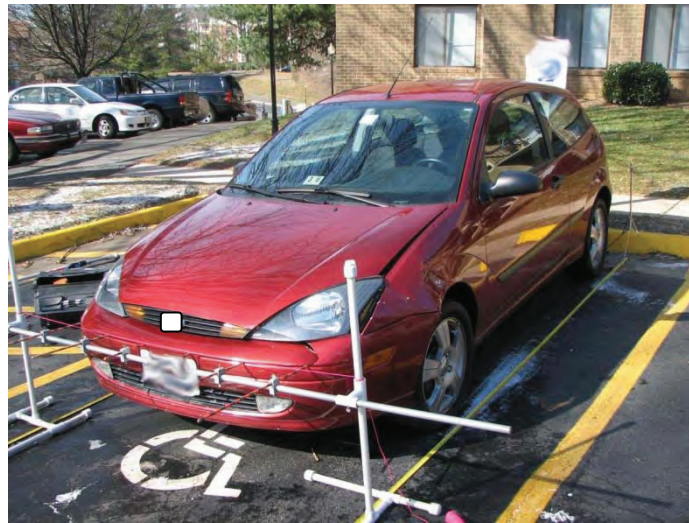
Example 1: This case involves an 81-year-old belt-restrained male driver involved in a minor frontal single-vehicle crash. His late model compact vehicle was approaching a parking space at low speed when the driver inadvertently accelerated the vehicle through the parking space. The vehicle jumped a curb and struck a building perpendicular to the vehicle's path. The delta V calculated by WINSMASH for the impact with the building was 14 kph (8.7 mph). The vehicle damage (CDC code = 12UFDW01), which is shown in Figure 7, was to the front and minor, there was no intrusion of vehicle interior components into the driver space, and the steering-wheel airbag did not deploy.

Figure 7. Example-1 case vehicle damage

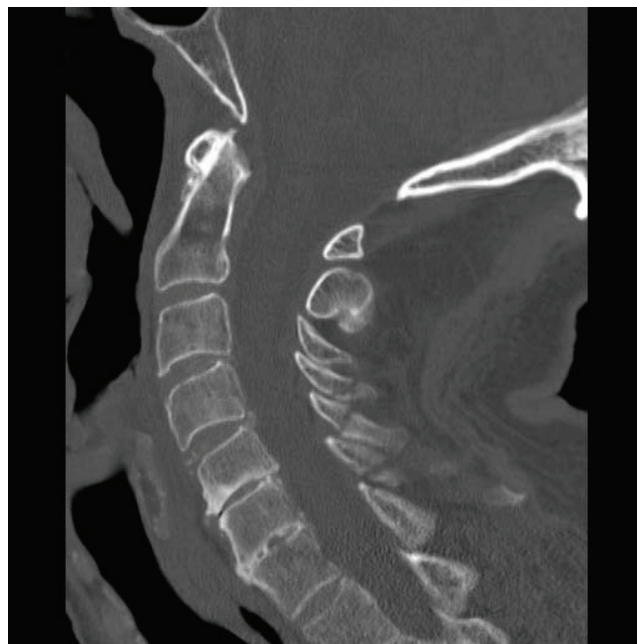
As shown by the CT scan of Figure 8, the driver sustained fractures of the C4-C7 spinous processes and lamina fractures at C7 and T5. The C7 lamina fracture is classified as an AIS 3 injury. The Injury Causation Scenario for this injury includes the following:

Figure 8. Sagittal CT scan of case occupant's cervical spine showing multiple posterior column fractures.

In narrative form, the undercarriage-to-curb impact caused both a longitudinal deceleration and a vertical acceleration of the vehicle that caused the driver to move forward and up relative to the vehicle interior. With no airbag deployment and relatively little space between the driver's head and the windshield header, the driver's forehead contacted the windshield header. Although there was no physical evidence of the head contact on the header, a head CT image indicated a contusion of the

upper-right region the scalp. This contact generated compression of cervical spine and, coupled with a resulting extension of the neck, caused the multiple spinous process and lamina fractures observed in the neck CT image.

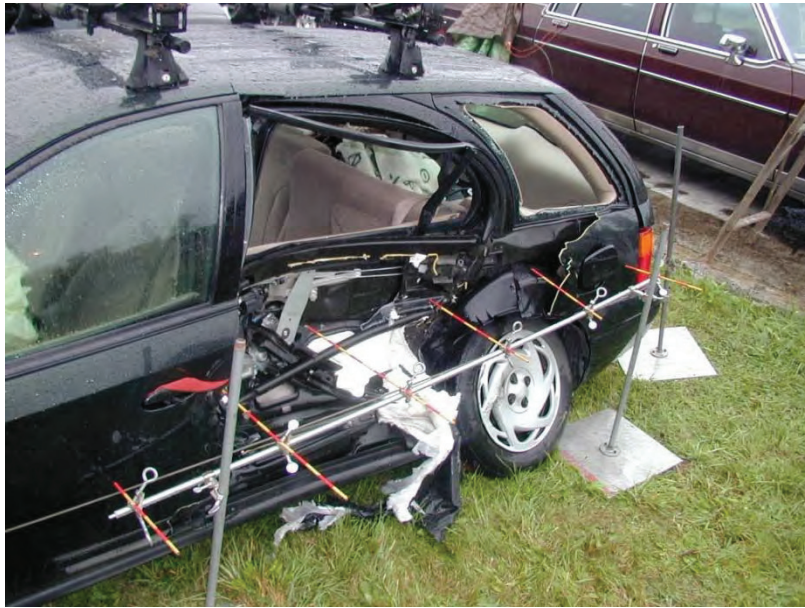
Example 2: This example involves a belt-restrained 8-year-old female seated on the left side of the second row of a late model compact sedan. The vehicle was entering an intersection when it was impacted in the middle of the left side by a two door sports car with a principal direction of force (PDOF) of 310 degrees.. The vehicle exterior damage (CDC code = 10LZAW03) is shown in Figure 9 and is confined primarily to the left-rear door with a maximum rightward intrusion of 9 cm. The calculated total delta V is 32 kph (20 mph of lateral delta V and longitudinal delta V). The case occupant's injuries include multiple brain lesions and diffuse brain bleeding and swelling. The BioTab analysis of the most serious brain injury is as follows:

Figure 9. Exterior damage to vehicle in Example 2

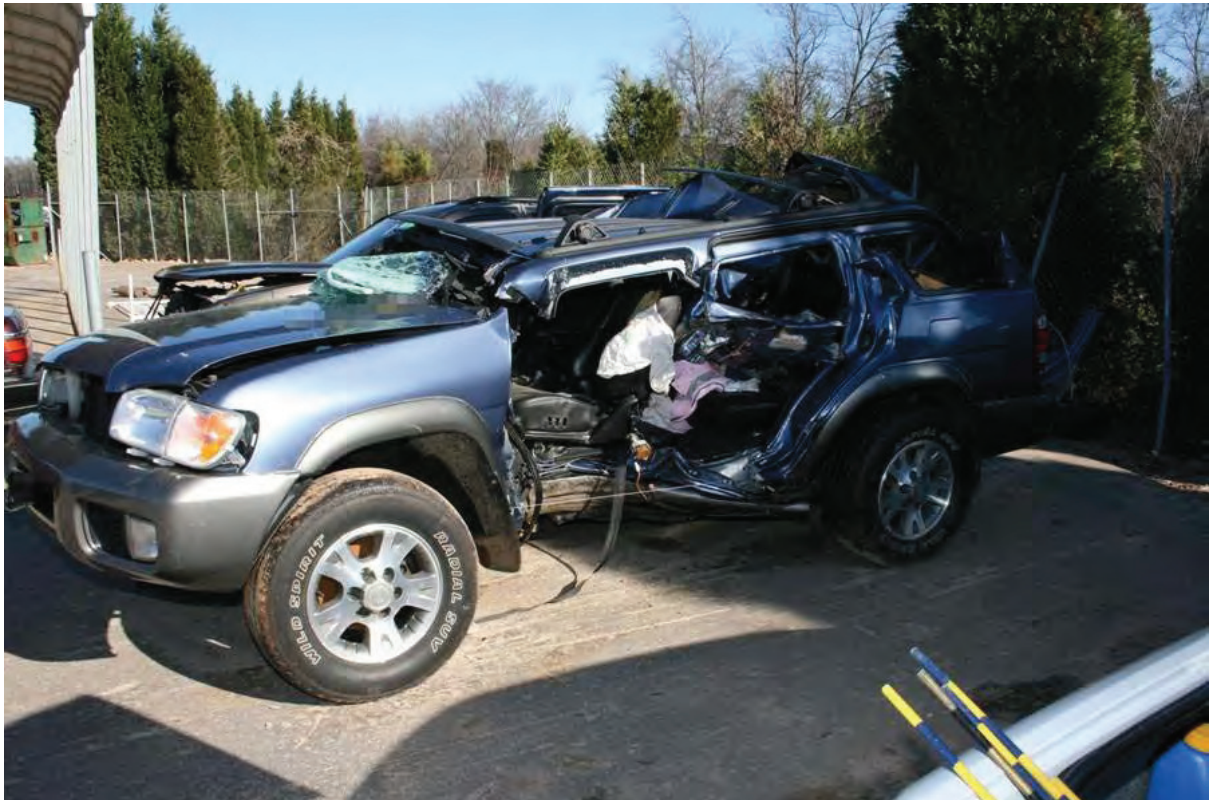
Example 3: In this crash, a 30-year-old female driver lost control of her sport utility vehicle, and the vehicle departed the roadway and the left side struck a large tree (PDOF = 270 degrees). The vehicle damage (CDC code = 89LPAW04) shown in Figure 10 was severe and the lateral delta V was calculated at 45 kph (28 mph). The case occupant sustained bilateral hip (acetabular) fractures as shown in the MRI/CT image of Figure 11. The ICSs for these two hip fractures are described below. For the left hip, rightward intrusion of the driver door interior is a contributing factor and for the right hip interior-door intrusion is a critical factor in the ICS.

Figure 10. Exterior vehicle damage for Example Case #3

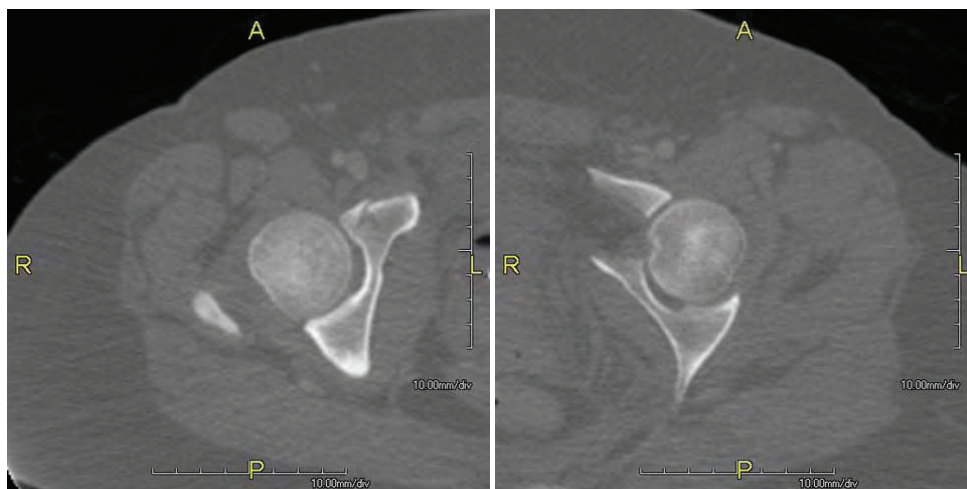
Figure 11. Image of case occupant showing bilateral acetabular fractures

Injury: Left acetabulum fracture (outboard lower extremity) (AIS code = 8526043)

Right acetabulum fracture (inboard lower extremity) (AIS code = 8526043)

ICS Description: Right hip loaded by center console with left hip loaded by door interior (nut-cracker scenario) (confidence = certain)

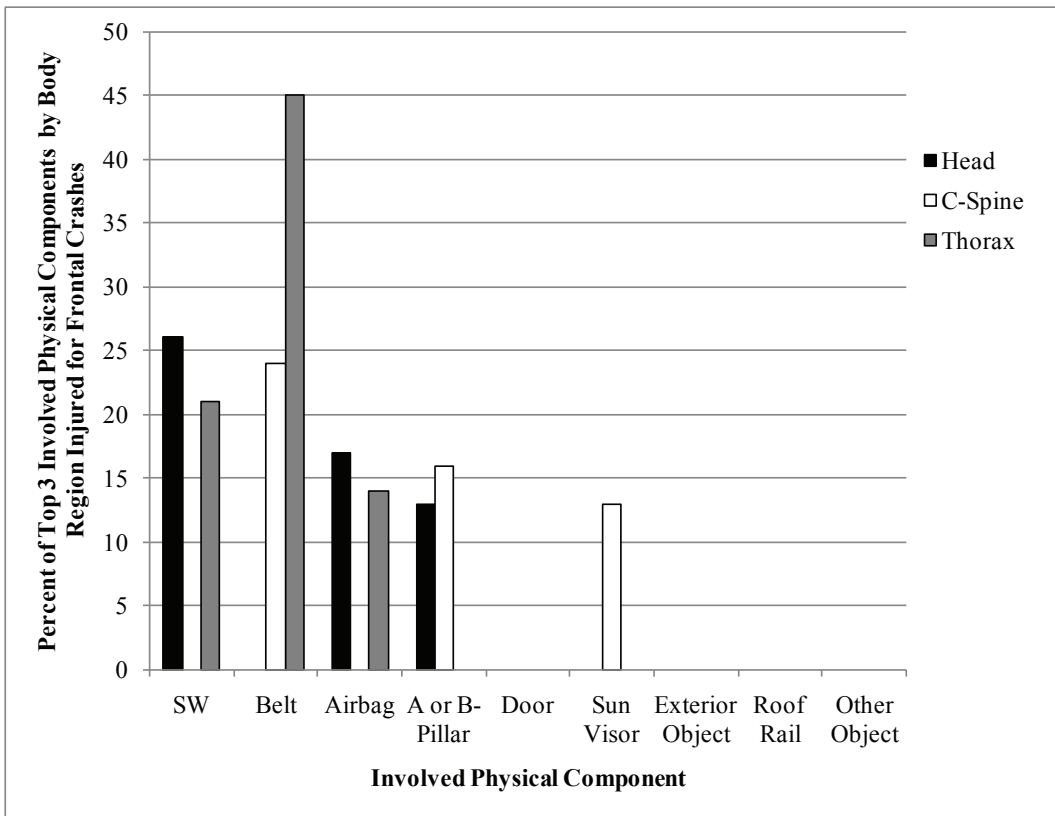
The three most frequently Involved Physical Components (IPC) coded for head, cervical spine, and thorax injuries by crash mode are shown in Figures A1, A2 and A3 of Appendix A. In frontal crashes, the steering wheel, seat belt, and airbag are commonly coded as the IPC for thoracic injuries. This is expected since a CIREN occupant must be restrained by the seat belt and/or airbag to be included in the database.

Figure A1. Percentages of the top 3 most frequent involved physical components for selected body regions in frontal crashes

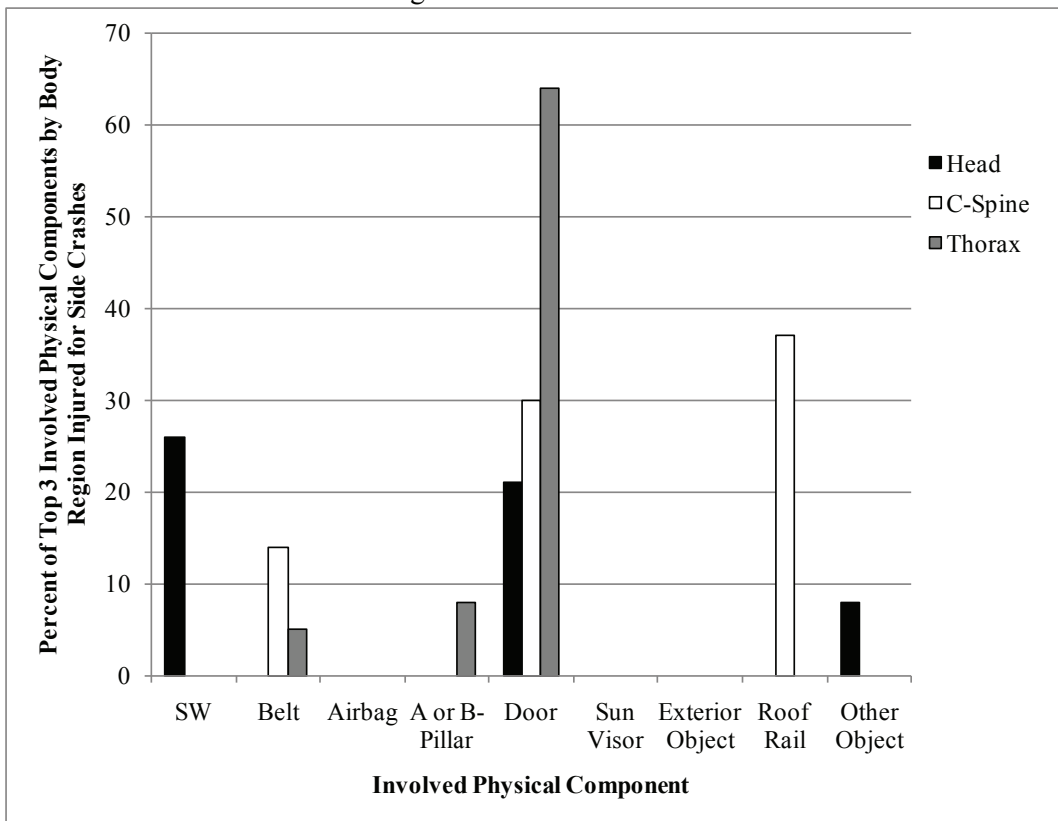
Figure A2. Percentages of the top-3 most frequent involved physical components for selected body regions for near-side occupant in side crashes

As expected, in side crashes, the door interior is the most frequent IPC for thoracic injuries. For head injuries, the IPCs coded by crash mode are generally as expected, but surprisingly indicate that the roof siderail is the most frequently coded IPC in rollover crashes. This is expected for the cervical-spine injuries regardless of crash mode as the head loading the roof siderail becomes the load path to the cervical spine and the resulting injuries. Ridella and Eigen (6) showed the strong association of cervical-spine injuries to roof siderail contact in their analysis of occupants in CIREN rollover crashes.

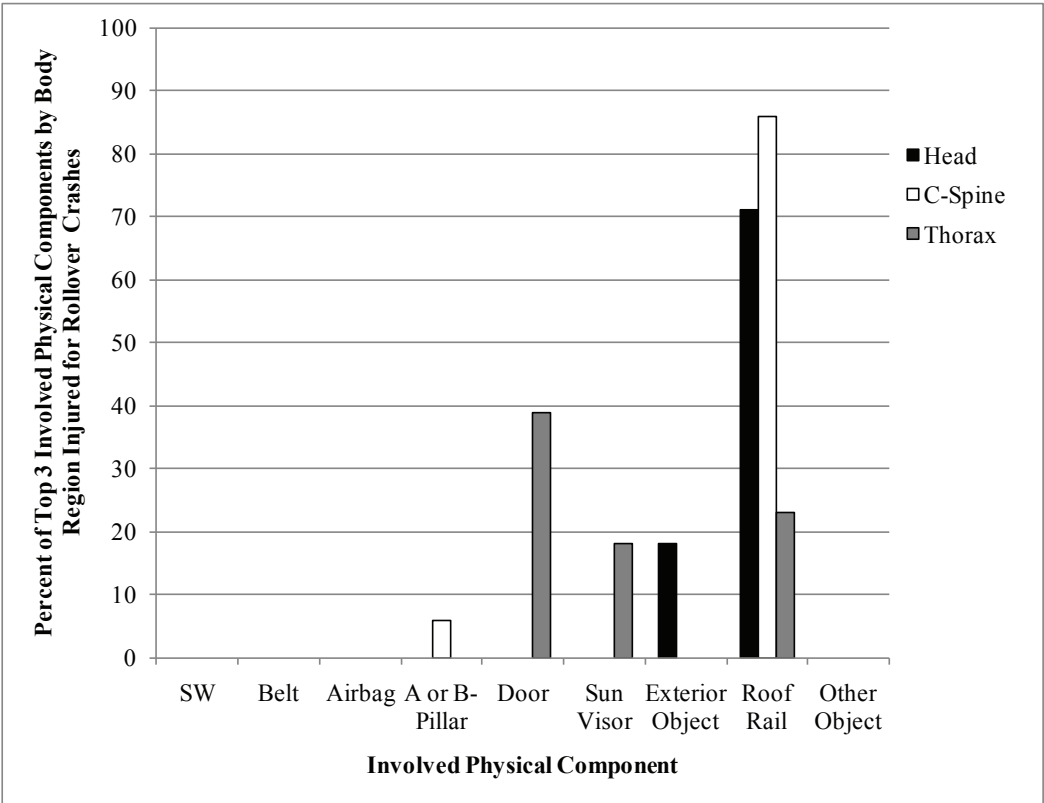
Figure A3. Percentages of the top 3 most frequent involved physical components for selected body regions in rollover crashes
